## Tijou Screen Conservation and Holding Repairs

### NHIG Bursary trainee placement at Hampton Court Palace

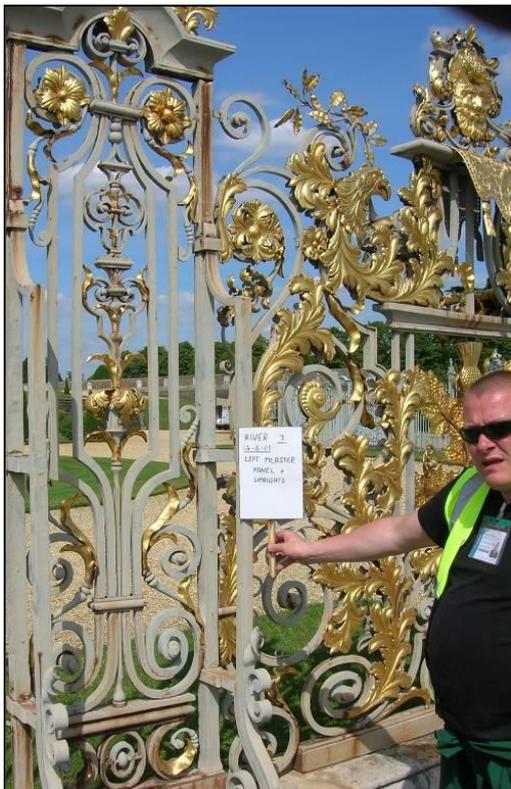
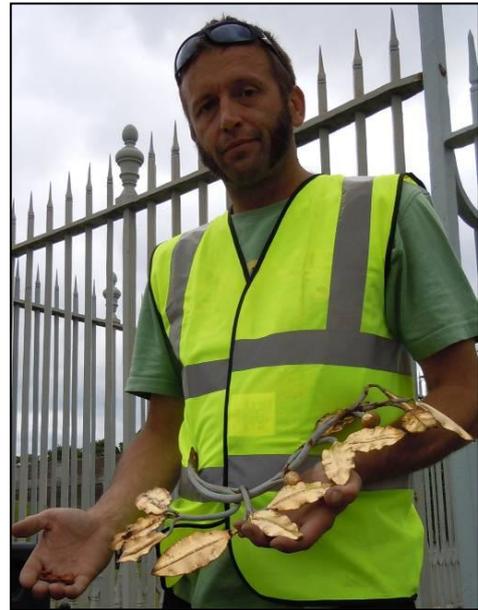
The fixings holding this leafwork overthrow were failing and were removed for safety and repair by Alex Coode.

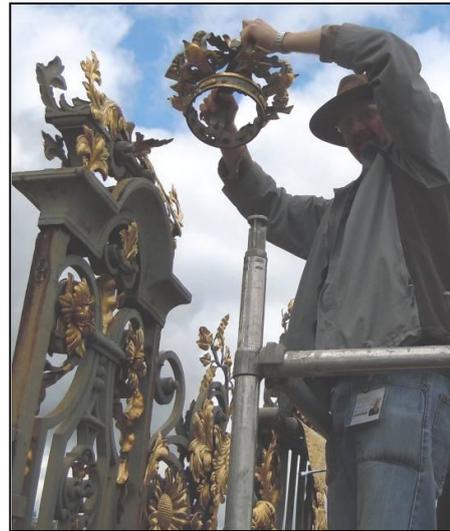
Simon Doyle removes one of the crowns with failing fixings.

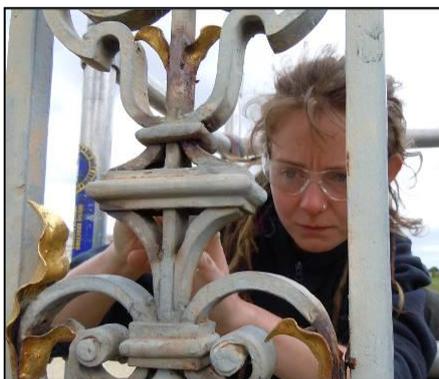
Jo Adkins removing paint to expose hidden corrosion.
