**INFORM**  
INFORMATION FOR HISTORIC BUILDING OWNERS

# Finials and terminals

## Introduction

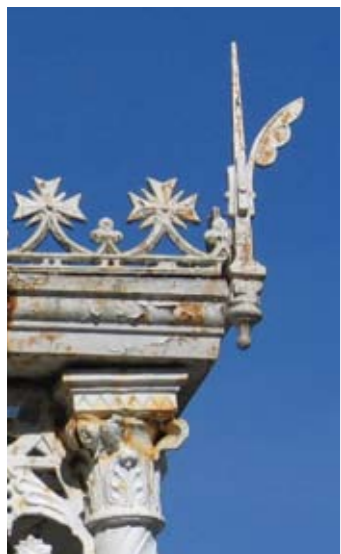
Cast iron finials can be fractured leading to the partial loss of decorative elements

Iron finials are generally durable and hard-wearing but, when paint breaks down, they also become more vulnerable to corrosion. Fixings attaching ornamental detailing to finials can corrode, leading to the loss of individual elements. Water seeping into joints or water traps can also accelerate this. Cast iron is a brittle material, and some projections are occasionally lost due to fracturing of the iron.

**Cast and wrought iron:** Metalwork should be inspected annually to check for signs of corrosion or deterioration, and should be repainted at least every 5 years. Badly damaged and missing sections should always be replaced on a like-for-like basis using the same material, manufacturing and assembly techniques.

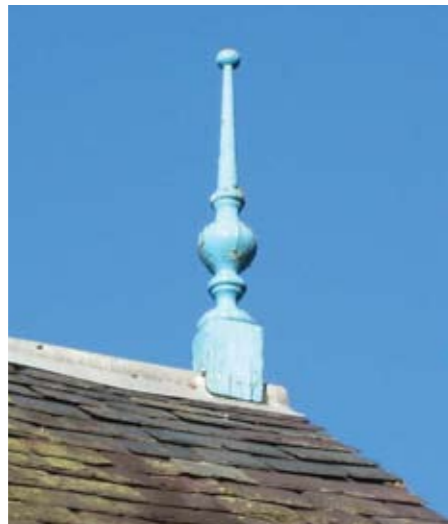
A timber finial in need of maintenance

**Timber:** Wooden finials should be painted at least every four years with a good quality exterior paint to maintain a good level of protection. Annual inspections, especially of the lead flashing around finials, are recommended.

When protective painted surface coatings break down, timber is left exposed and this makes it prone to rot and decay. It is therefore essential to maintain paintwork in good condition.

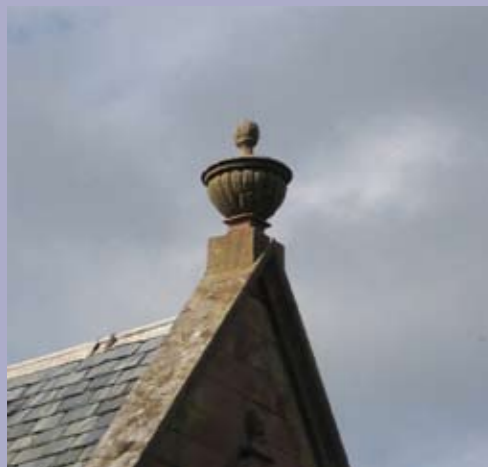
A stone terminal on a gable end

See also *INFORM: Masonry Decay*. Stone finials commonly terminate gable ends and were traditionally built into the gable stonework using a lime mortar. While stone is a durable material, the action of water, wind, atmospheric pollution and human intervention (such as the application of silicone or linseed oil to ‘waterproof’ the stone) can lead to decay and fracturing. Over

time, the lime mortar holding a finial in place may begin to break down, causing the finial to become unstable, and posing a threat to the safety of pedestrians at street level below as a result. Metal cramps anchoring a finial in place may also corrode, causing fracturing of the stone as rust expands.

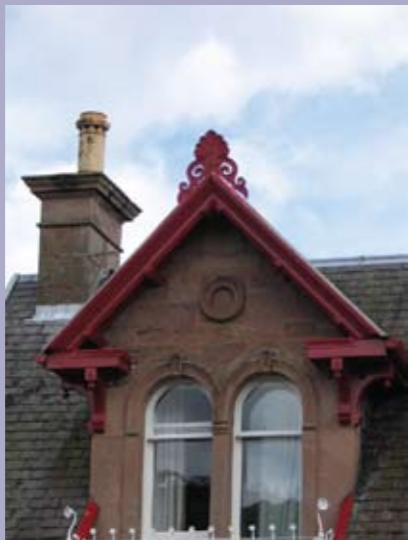
A cast iron finial

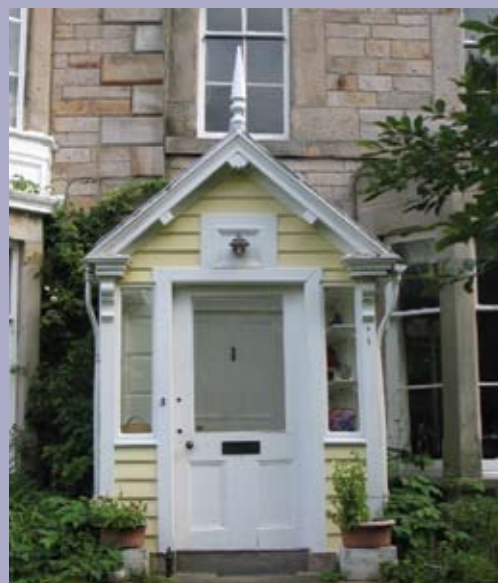
A timber finial above an entrance porch

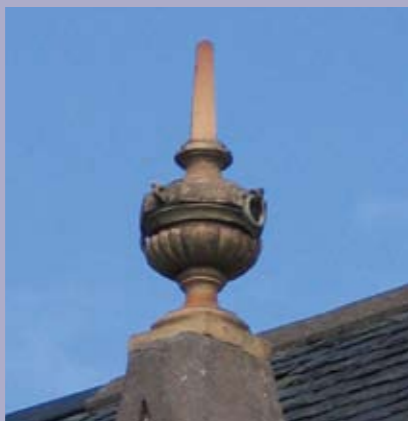
A terracotta finial

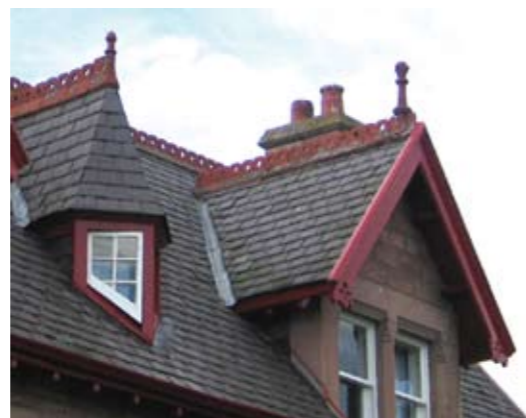
Terracotta finials were often complemented by decorative cresting

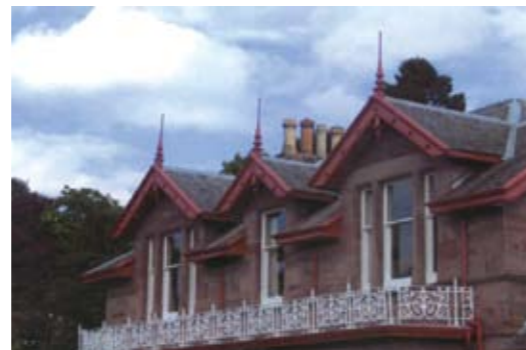
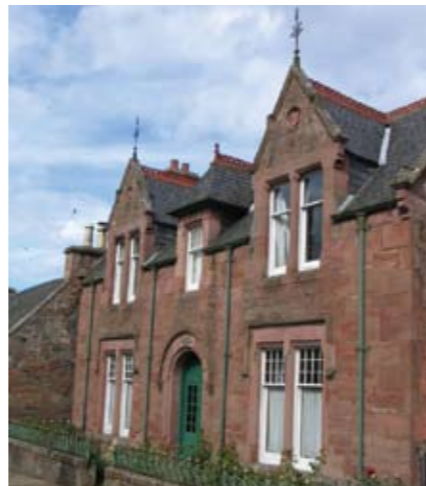
Cast iron finials were frequently complemented by cast iron railings cresting and rainwater goods

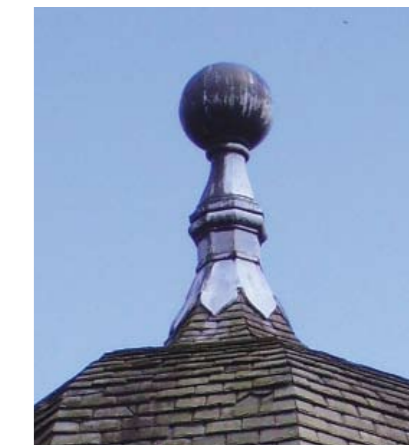
A lead concealed finial

replaced over time. It may become thin due to corrosion and wear. Splits and cracks can develop due to stresses in the material which are caused by expansion and contraction of the material as ambient temperatures rise and fall.

**Lead:** Lead will need to be replaced periodically as it will thin over time due to corrosion and wear. Lead can be purchased in different thicknesses (“codes”), and an appropriately skilled lead-worker can advise on the most suitable type. Where cracks and tears appear, it may be necessary to create an appropriately detailed joint at this point to prevent the stresses in the material that have caused the crack.

Timber finials were occasionally covered in lead sheet to protect them and to form an architectural feature. Lead is a durable material but will eventually need to be
